A RESOLUTION ADOPTING THE  
ADA TRANSITION PLAN  
FOR THE TOWN OF LOWELL

# ADA Self-Evaluation and Transition Plan

July 2023

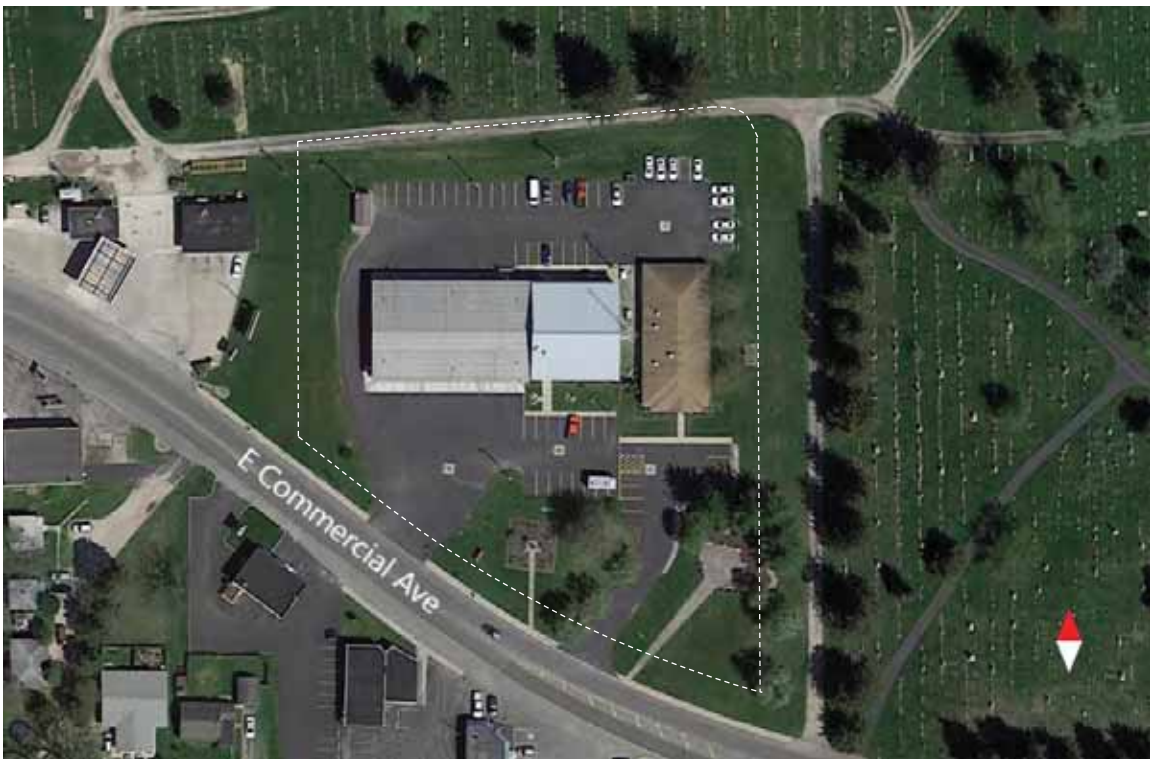
### 2.2 Existing Site Layout

The existing site is located at 1331 E. Commercial Avenue in Lowell, Indiana. The Lake County GIS indicates the site to be approximately 2.2 acres. The site contains two buildings. Building 1, the Fire and EMS Building, is the subject of this assessment. Building 2 is the Police Station. The buildings are approximately 17-feet apart which has impact on the code requirements for the facility. It has been noted by the staff that conflicts arise when emergency vehicles from both agencies depart from the site. The access drive on the west side of the facility is narrow and contains blind spots for potential conflicts of emergency vehicles. It appears that the public access to the facility is through the same drive as the fire and EMS apparatus access. The needs of the site and facilities will be further studied in Task II of the comprehensive planning process.
